PA-34-200T PIPER SENECA II

Quick Reference Preflight Checklist

PREFLIGHT INSPECTION

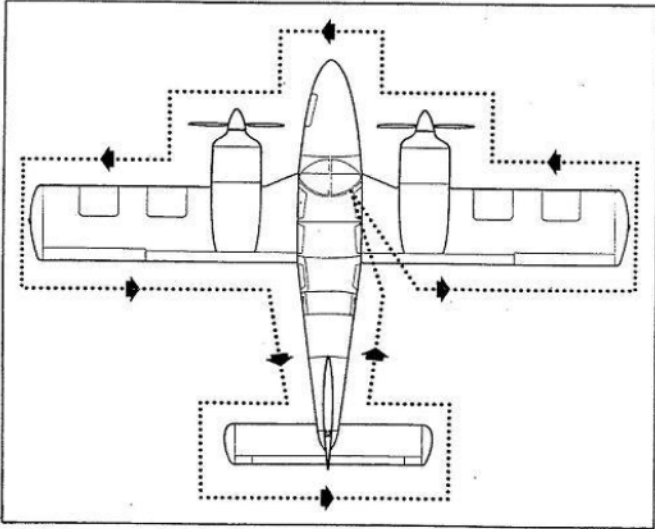
CABIN

RIGHT WING

NOSE

LEFT WING

EMPENNAGE & AFT FUSELAGE
